Parcel C (Parcels C and UC-2)
Five-Year Review Site Inspection Photograph Locations
Five-Year Review of Remedial Actions
Hunters Point Naval Shipyard, San Francisco, California

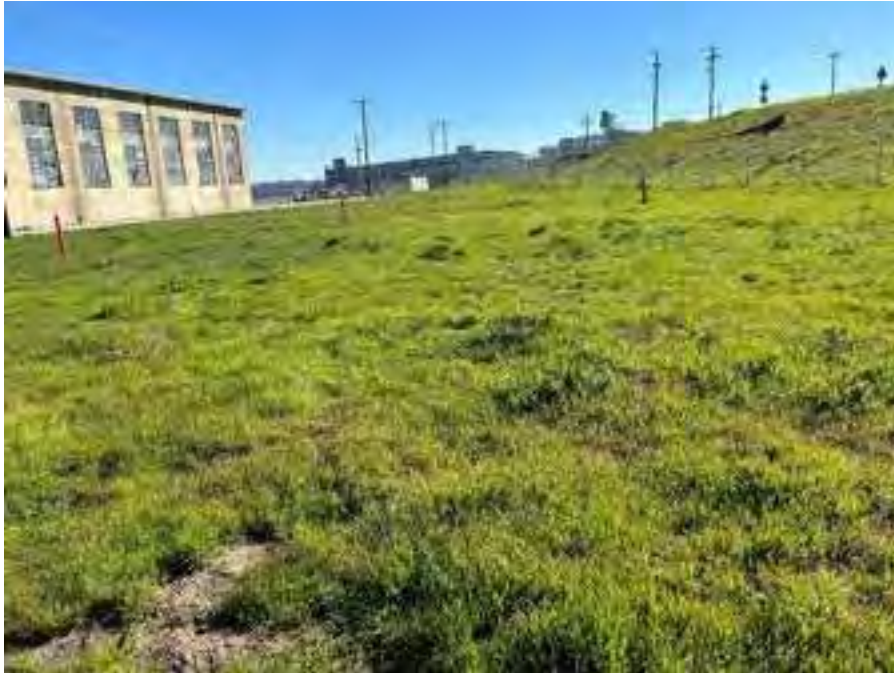
Parcel C Photograph 1: Soil cover west of Building 134. Facing southeast.
Photographed by: Marcella Navas/CH2M, 2/9/2023

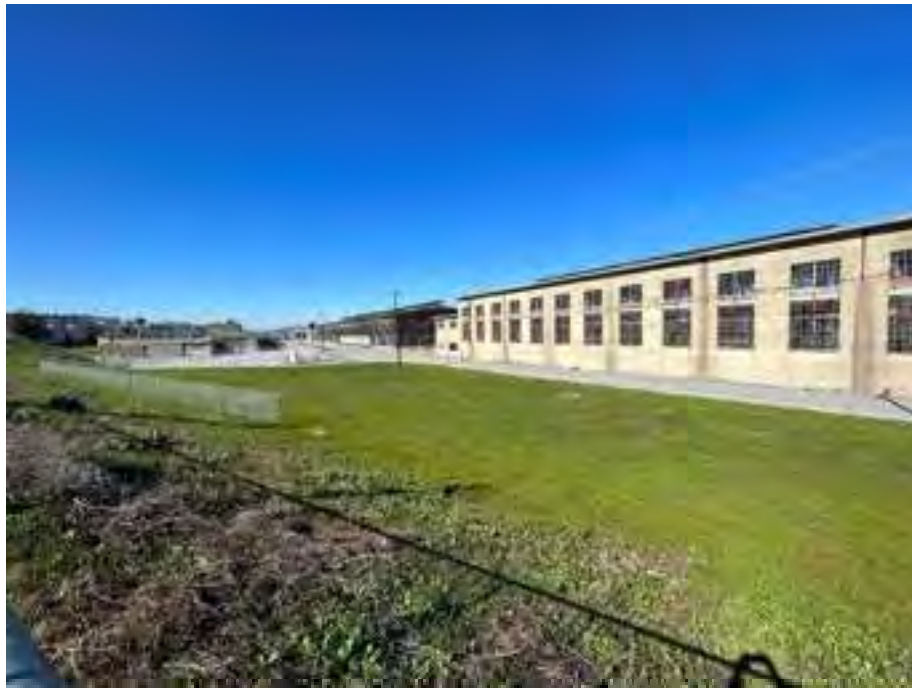
Parcel C Photograph 2: Soil cover west of Building 134. Facing northwest.
Photographed by: Marcella Navas/CH2M, 2/9/2023

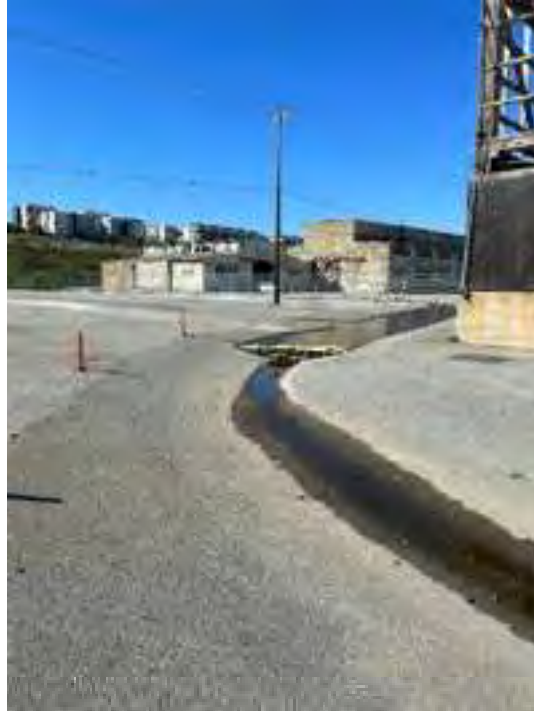
Parcel C Photograph 3: Drainage swale southwest of Building 134. Facing southwest.
Photographed by: Marcella Navas/CH2M, 2/9/2023

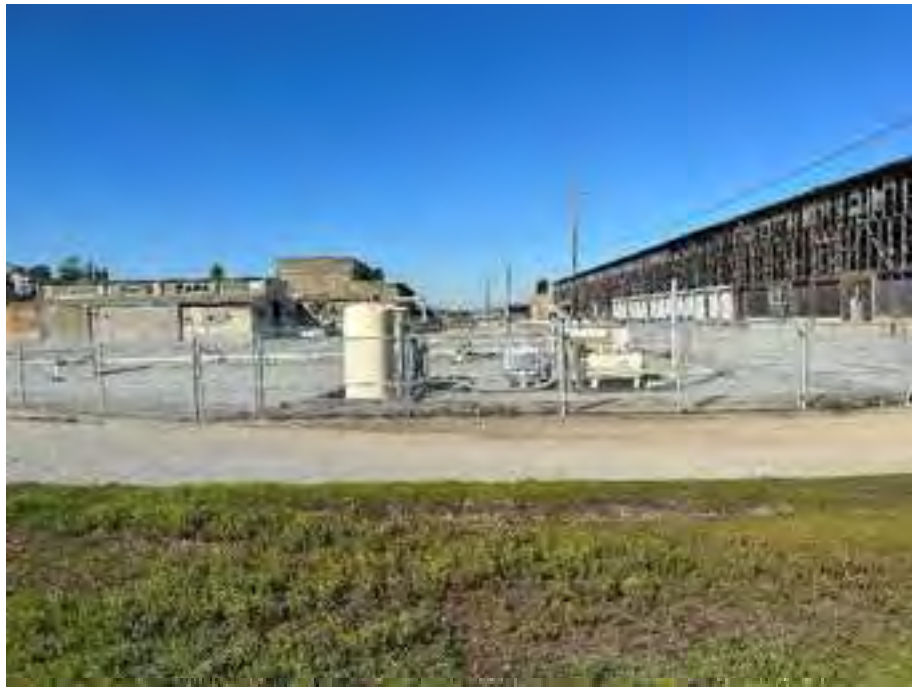
4.SVE treatment system components <input type="checkbox"/> Functioning <input checked="" type="checkbox"/> Good condition <input type="checkbox"/> Needs Maintenance <input type="checkbox"/> N/A			
Remarks <u>SVE systems are currently not operating until active treatment is complete and an evaluation of the remedy is completed. Piping is in good condition (Photographs 4 and 5).</u>

Parcel C Photograph 4: SVE treatment systems surrounded by chain-link fence. Facing west.
Photographed by: Marcella Navas/CH2M, 2/9/2023

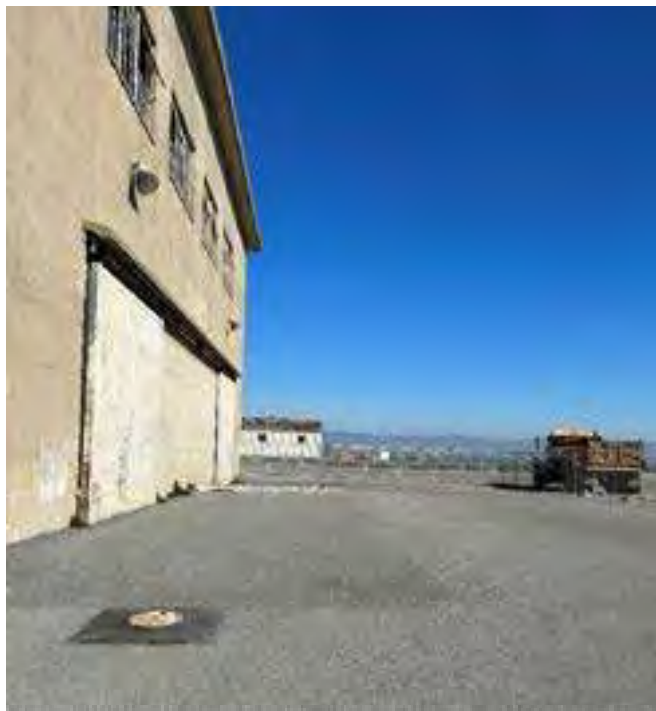
Parcel C Photograph 6: Asphalt pavement cover southeast of Building 134. Facing north.

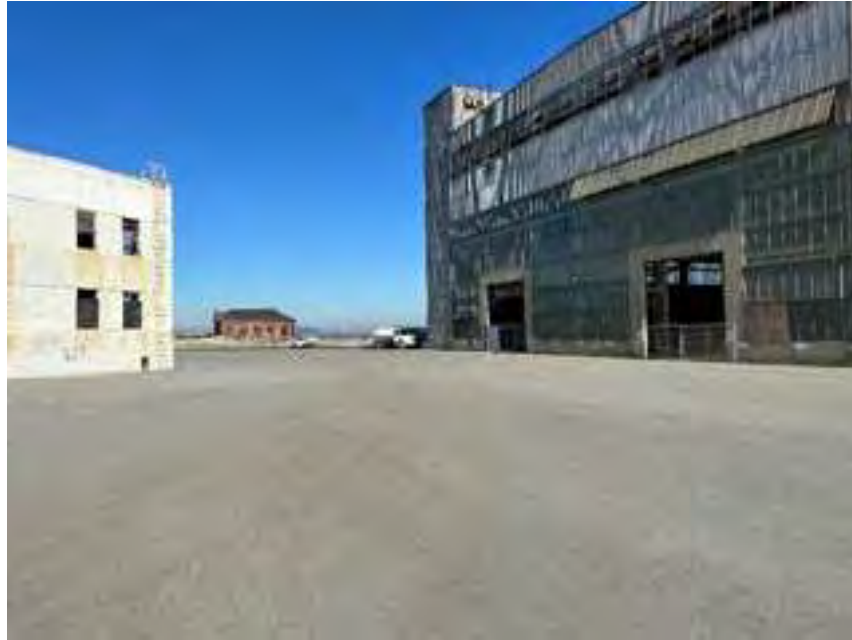
Parcel C Photograph 7: Asphalt pavement cover southwest of Building 214 along Lockwood Avenue. Facing northwest.

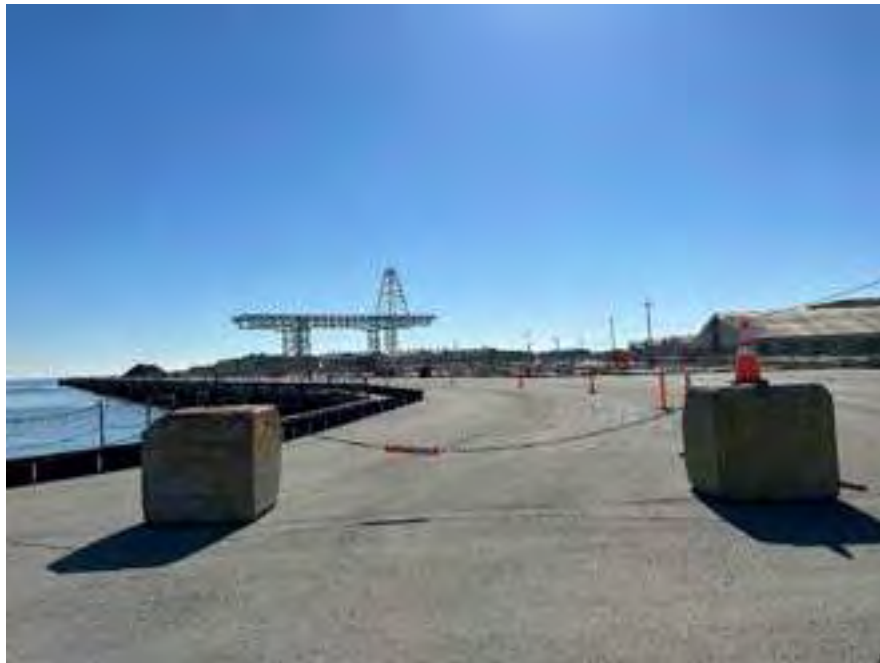
Parcel C Photograph 8: Asphalt pavement cover alongside Parcel G and Parcel U2. Barrier to prevent access. Facing south.

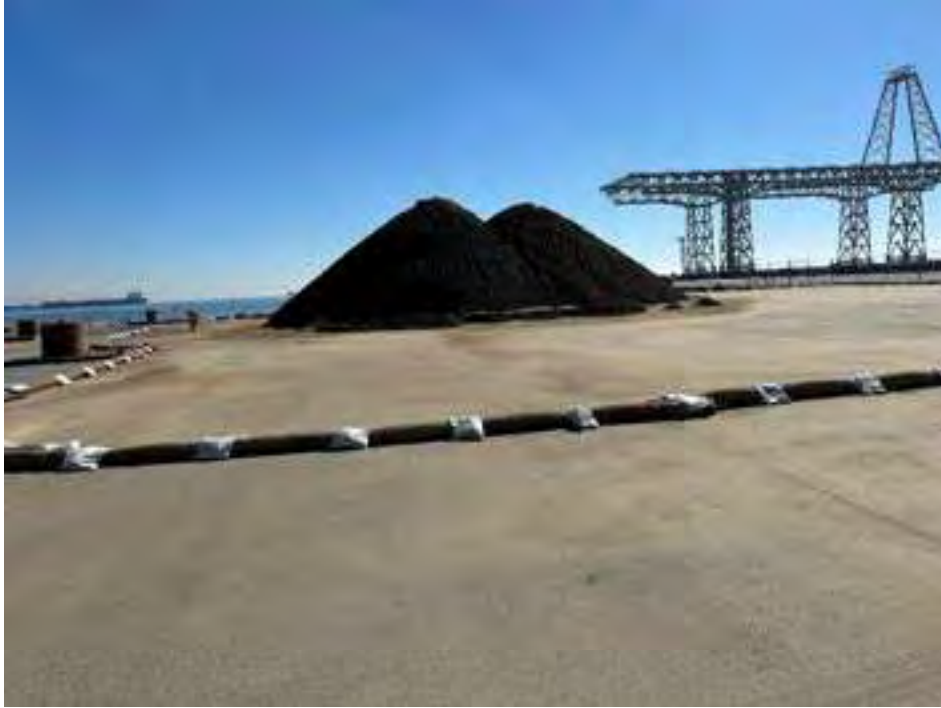
Parcel C Photograph 11: Storage of stockpiles with stormwater management best management practices surrounding and intact. Facing northeast.

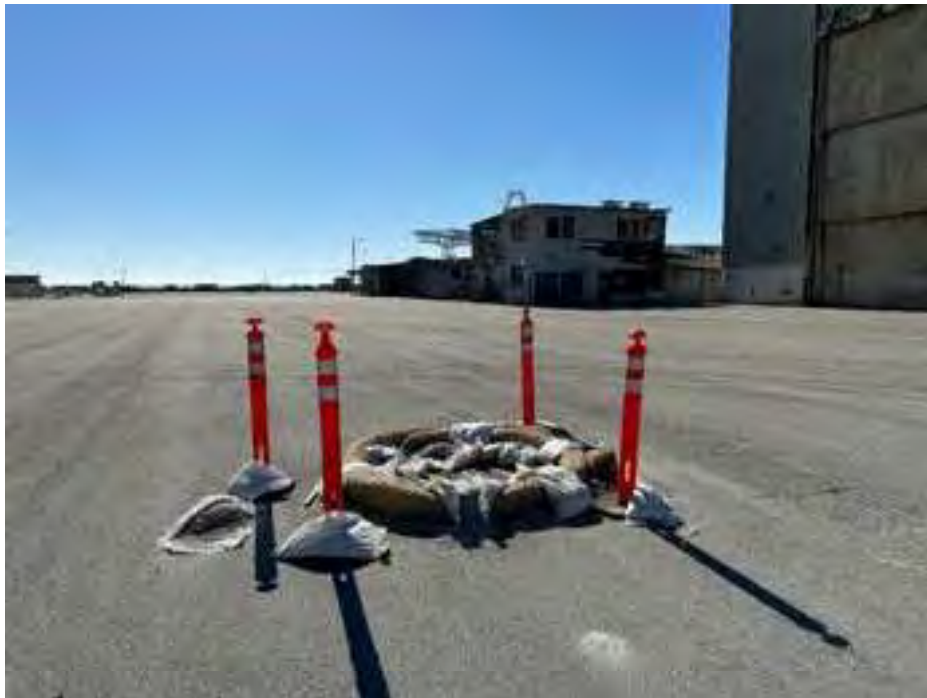
Parcel C Photograph 12: Stormwater best management practice around catch basin west of Building 231. Facing southeast.

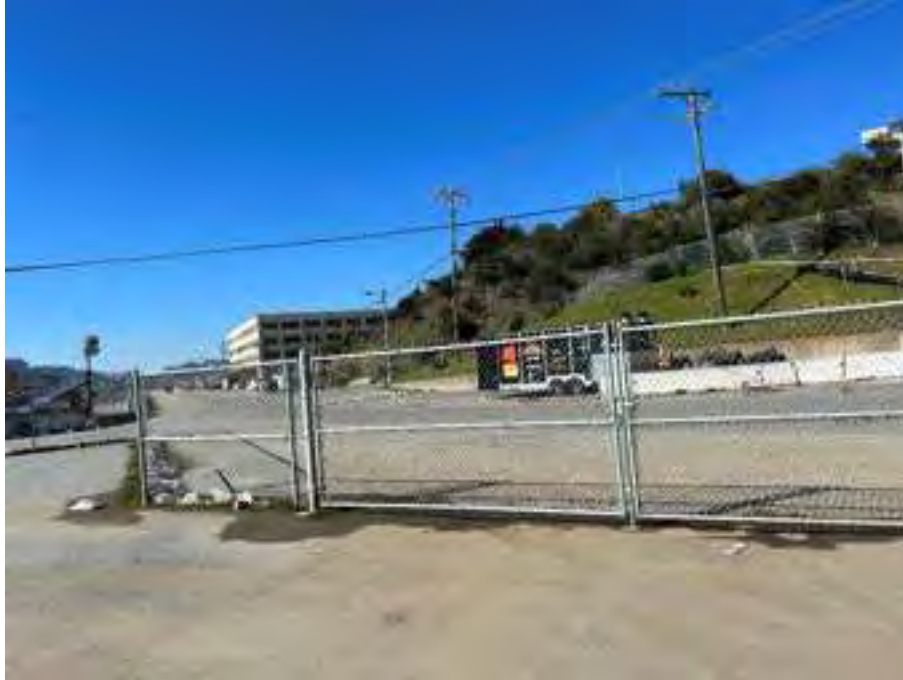
Parcel C Photograph 17: Chain-link fence in between parcel UC-2 along Fischer Avenue. Facing west.

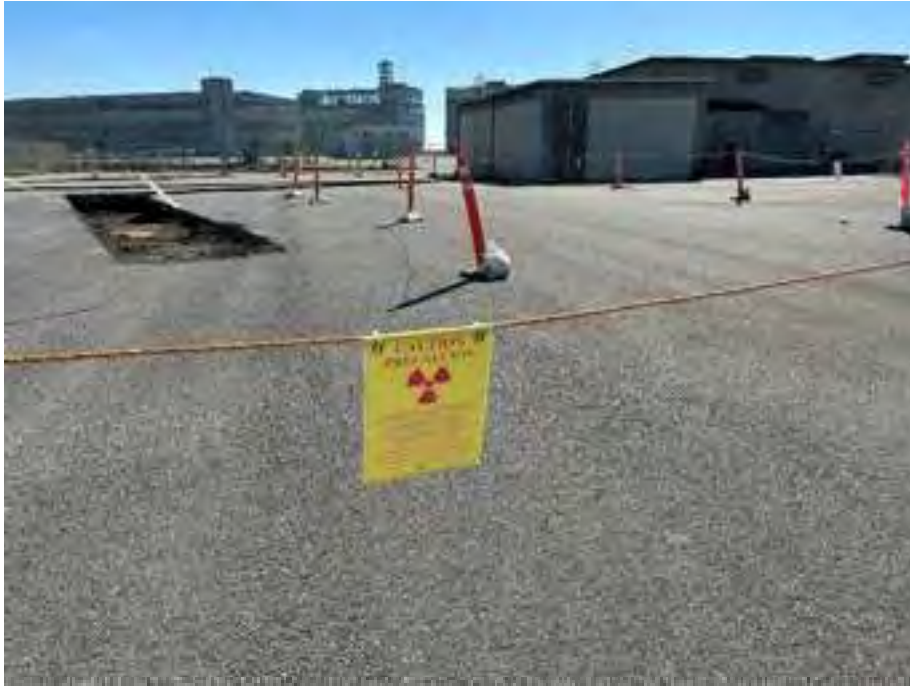
Parcel C Photograph 19: Signs signaling caution near trenching between of Building 134 and 135 outside of gated area of Parcel B-1. Facing southeast.

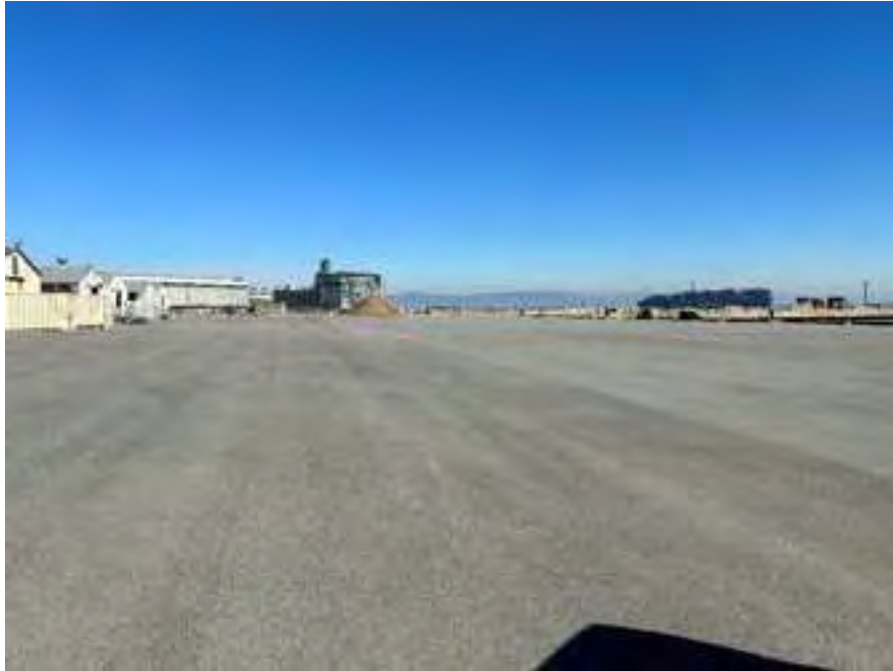
Parcel D-1 Photograph 1: Asphalt pavement cover adjacent to Parcel G. Facing northeast.

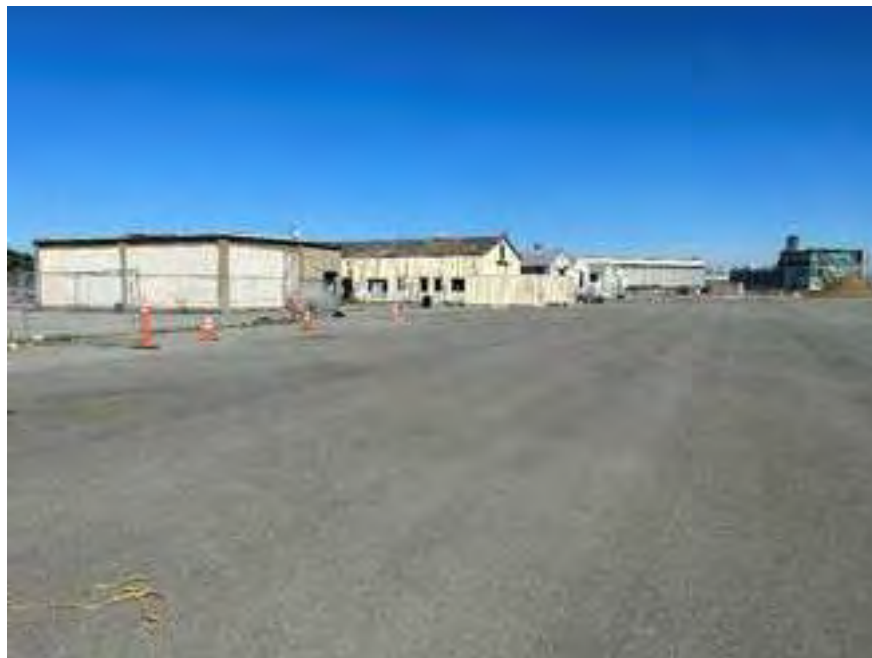
Parcel D-1 Photograph 2: Asphalt pavement cover adjacent to Buildings 306 and 274. Facing northwest.

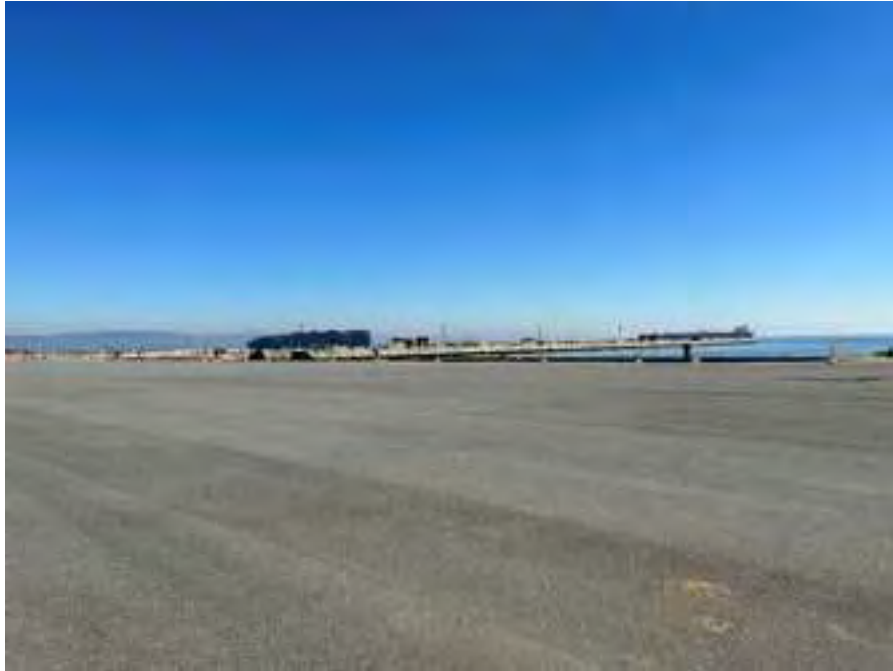
Parcel D-1 Photograph 3: Asphalt pavement cover adjacent to Buildings 306 and 274. Facing northeast.

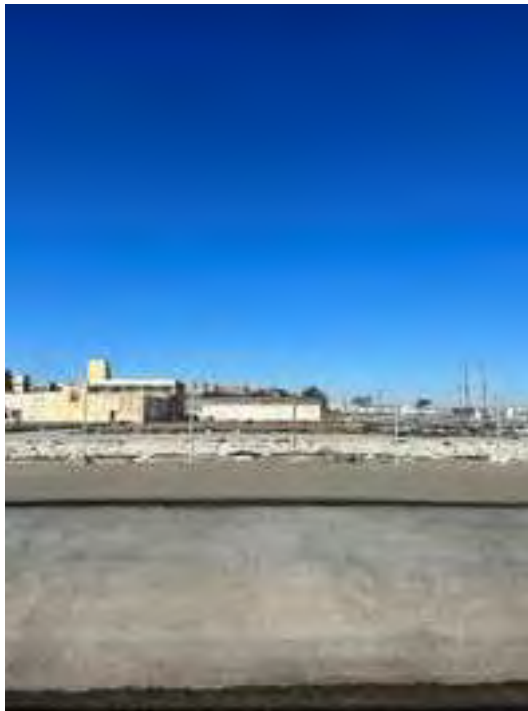
Parcel D-1 Photograph 6: Drainage swale adjacent to Parcel G. Facing northwest.
Photographed by: Marcella Navas/CH2M, 2/9/2023

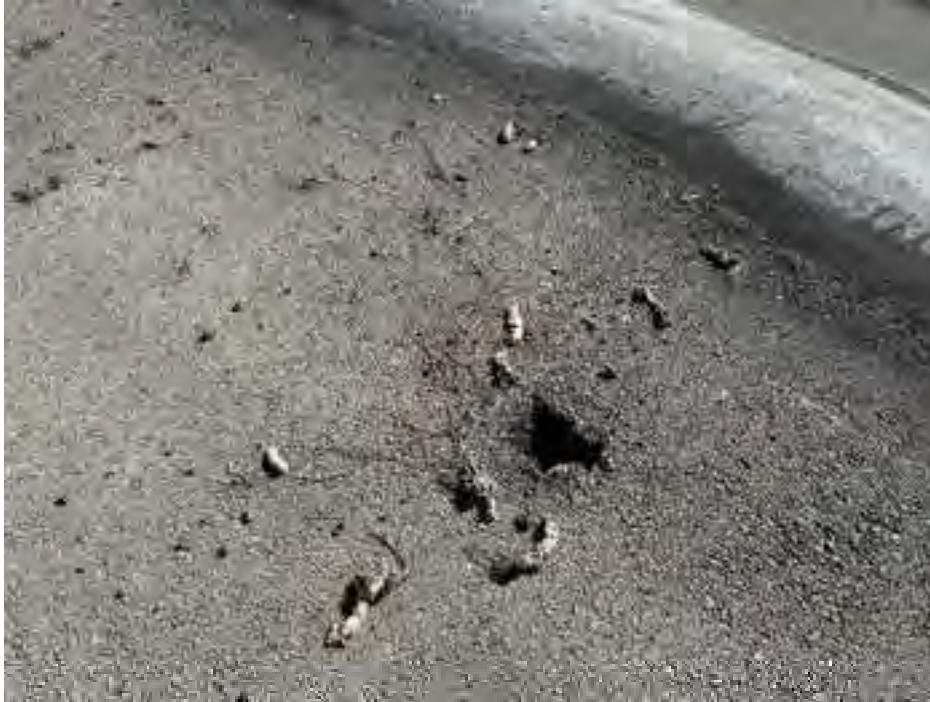
2.	Cracks Remarks <u>Minor cracks along drainage swale and flat asphalt cover where vegetation is growing (Photographs 7, 8, and 9).</u>	<input type="checkbox"/> Location shown on site map	<input type="checkbox"/> Cracking not evident

3.	Erosion Remarks <u>None</u>	<input type="checkbox"/> Location shown on site map	<input checked="" type="checkbox"/> Erosion not evident
4.	Holes Remarks <u>Small hole from vegetation growth observed (Photograph 7).</u>	<input checked="" type="checkbox"/> Location shown on site map	<input type="checkbox"/> Holes not evident

Parcel D1 Photograph 7: Hole and vegetation adjacent to asphalt drainage swale. Facing northwest.

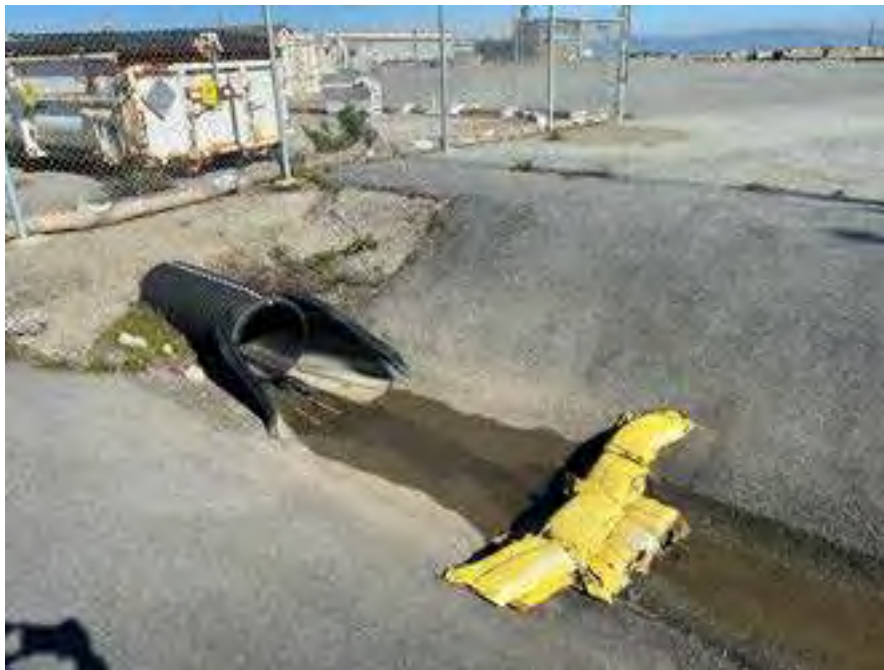
Parcel D-1 Photograph 8: Drainage swale adjacent to Parcel G. Minor vegetation growth in cracks along the seam between swale material and flat surface material. Facing northwest.

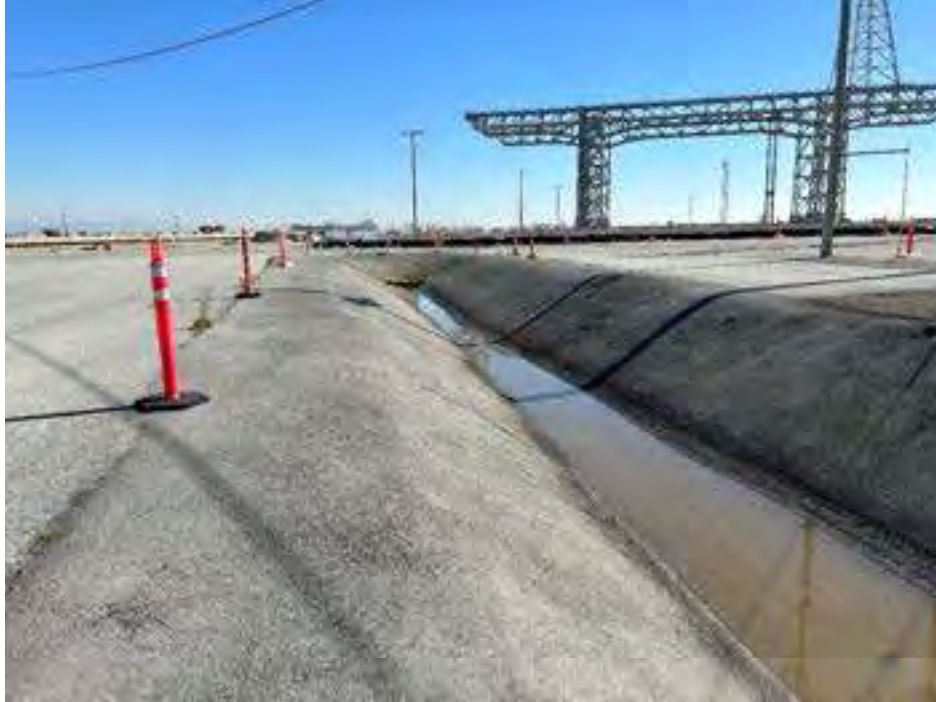
Parcel D-1 Photograph 9: Drainage swale with water southeast to Building 307. Facing northeast.

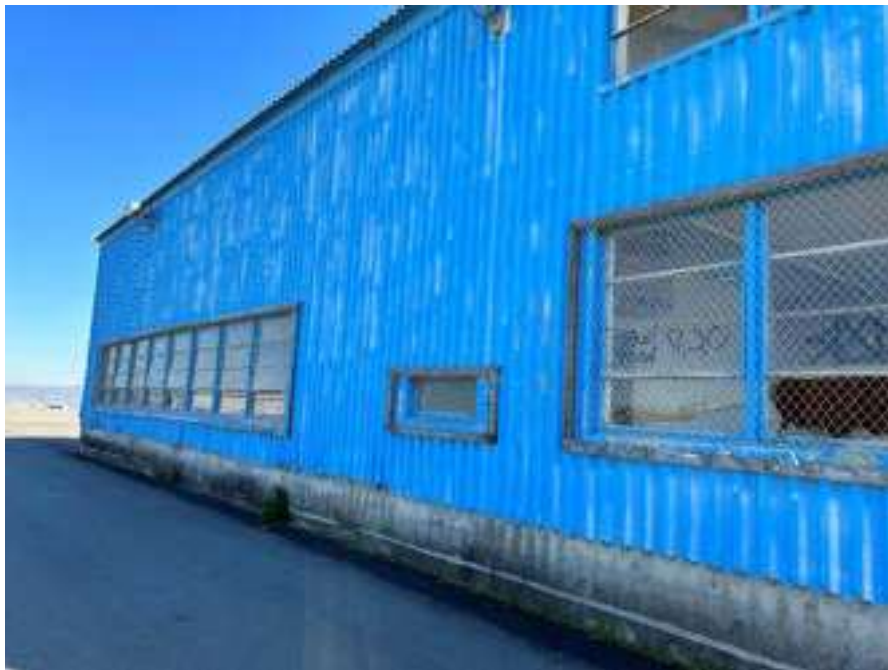
Parcel D-1 Photograph 10: Building 381, vegetation growth in the seam between exterior cover and building foundation. Facing northeast.

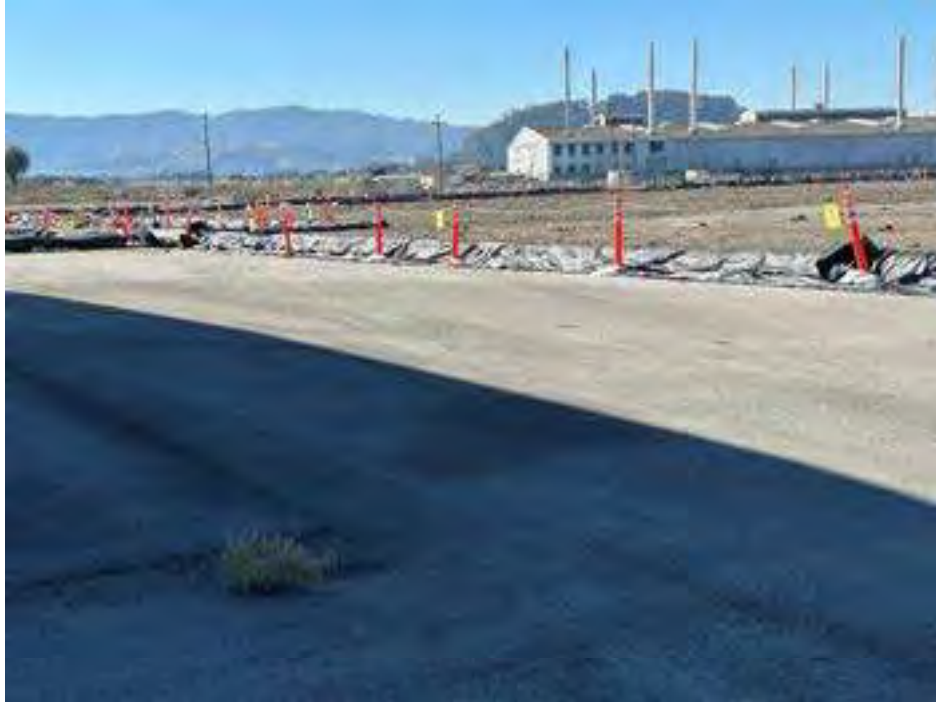
Parcel D-1 Photograph 11: Stormwater management best management practices southwest of Building 307. Facing southwest.

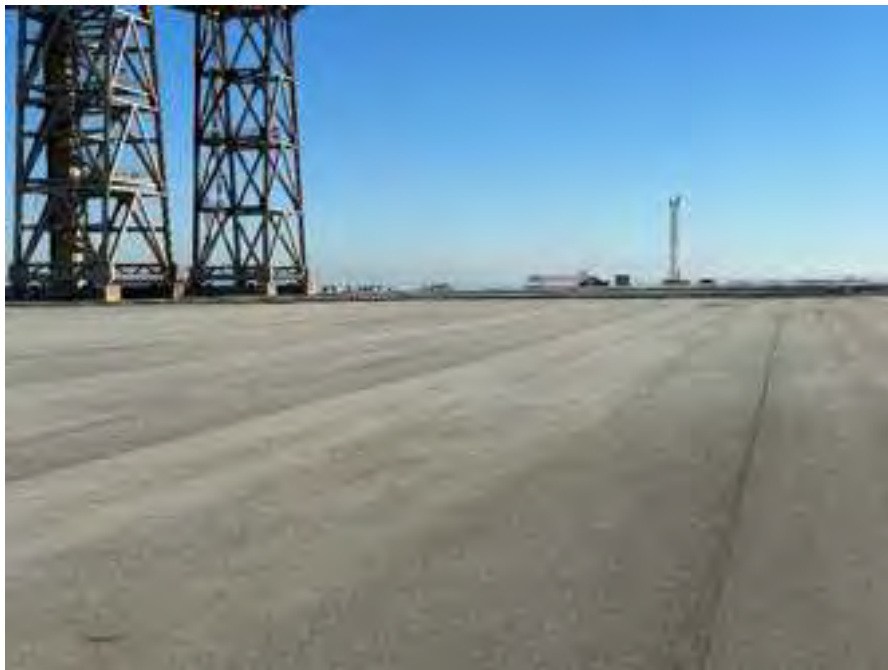
Parcel D-1 Photograph 12: Asphalt pavement cover between Buildings 381 and 383. Facing northeast.

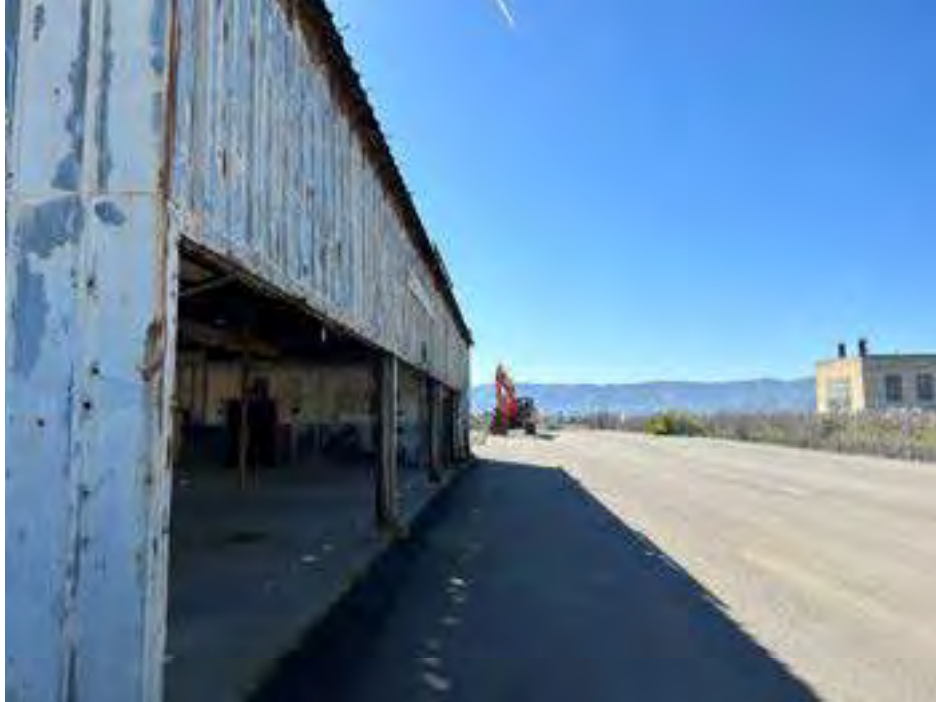
Parcel D-1 Photograph 13: Asphalt pavement cover adjacent to Building 530. Facing southwest.

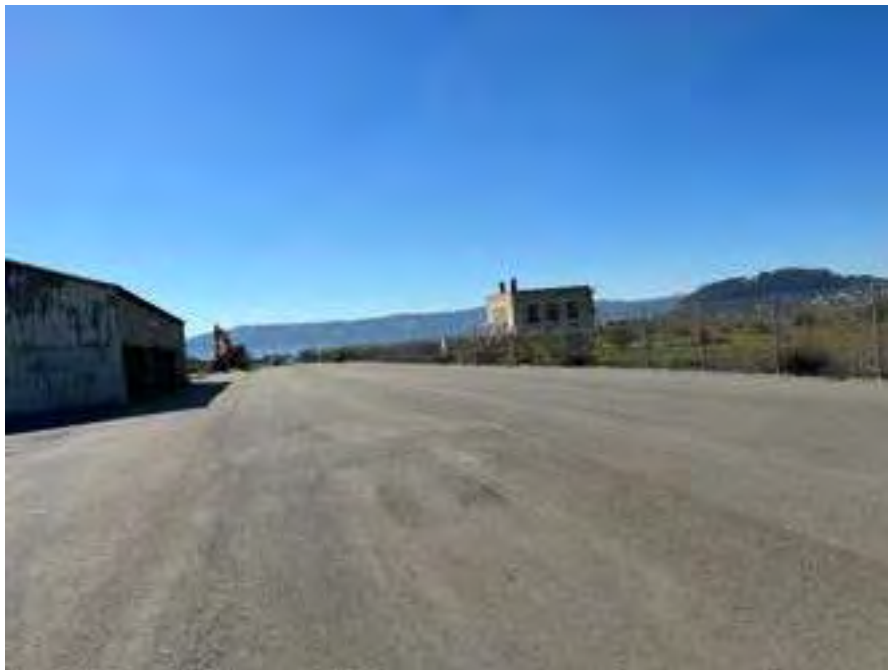
Parcel D-1 Photograph 14: Asphalt pavement cover adjacent to Building 530. Facing southwest.

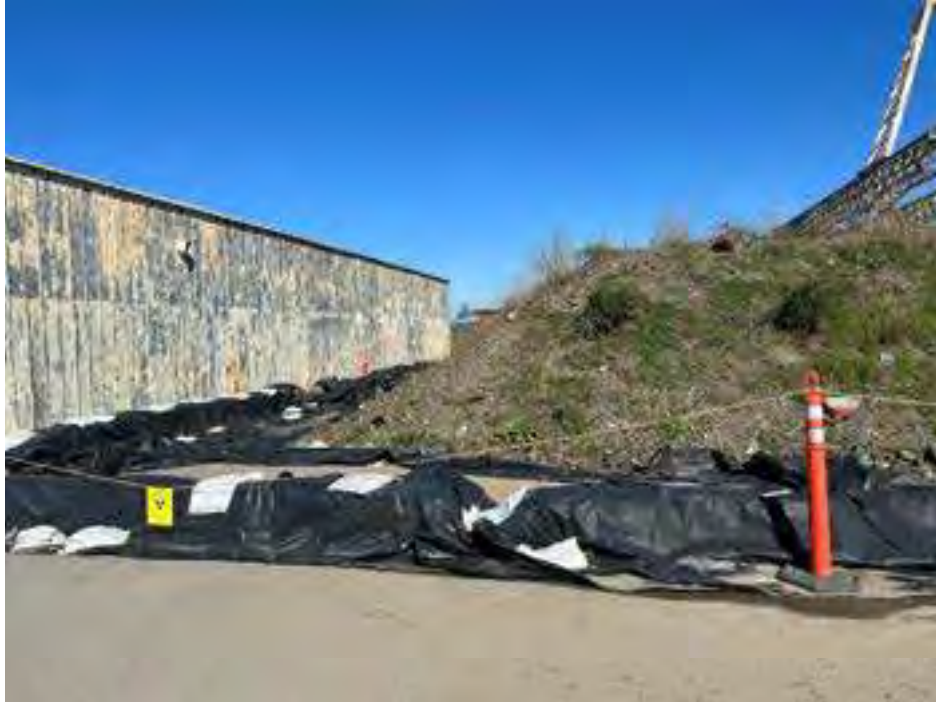
Parcel D-1 Photograph 15: Stockpile east of Building 525 within secondary containment and signage. Facing northeast.

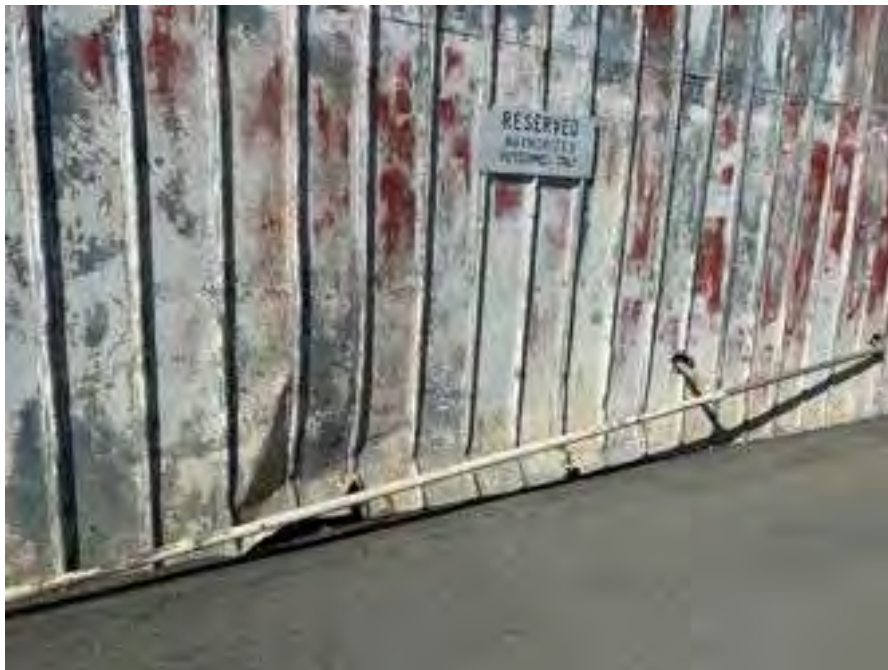
Parcel D-1 Photograph 16: Building 526 foundation. Facing southeast.

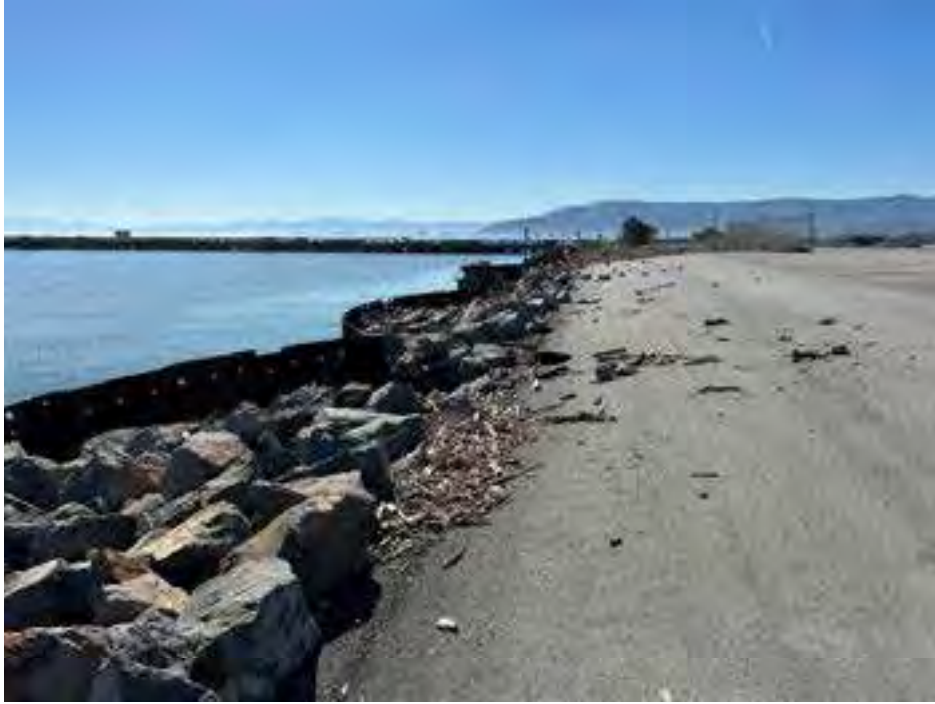
6.	Alternative Cover (Shoreline Revetment) Remarks <u>Generally good condition, smaller rocks (3- to 4-inch diameter) appear to have been washed onto the durable cover from the shore (Photographs 17 and 18).</u>	<input type="checkbox"/> N/A

Parcel D-1 Photograph 17: Shoreline revetment east of Building 381. Facing southeast.
Photographed by: Marcella Navas/CH2M, 2/9/2023

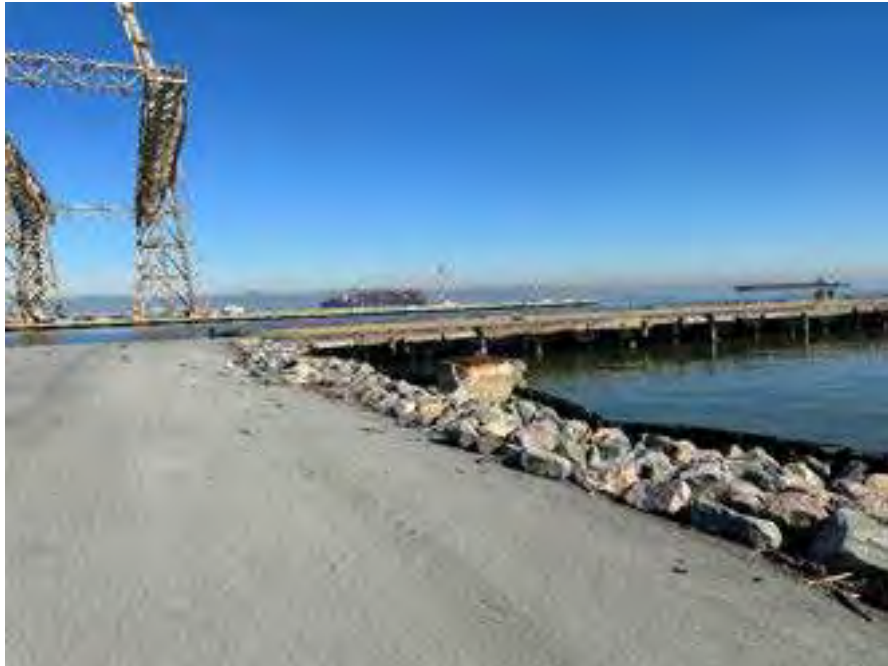
Parcel D-1 Photograph 18: Shoreline revetment east of Building 381. Facing northeast.
Photographed by: Marcella Navas/CH2M, 2/9/2023

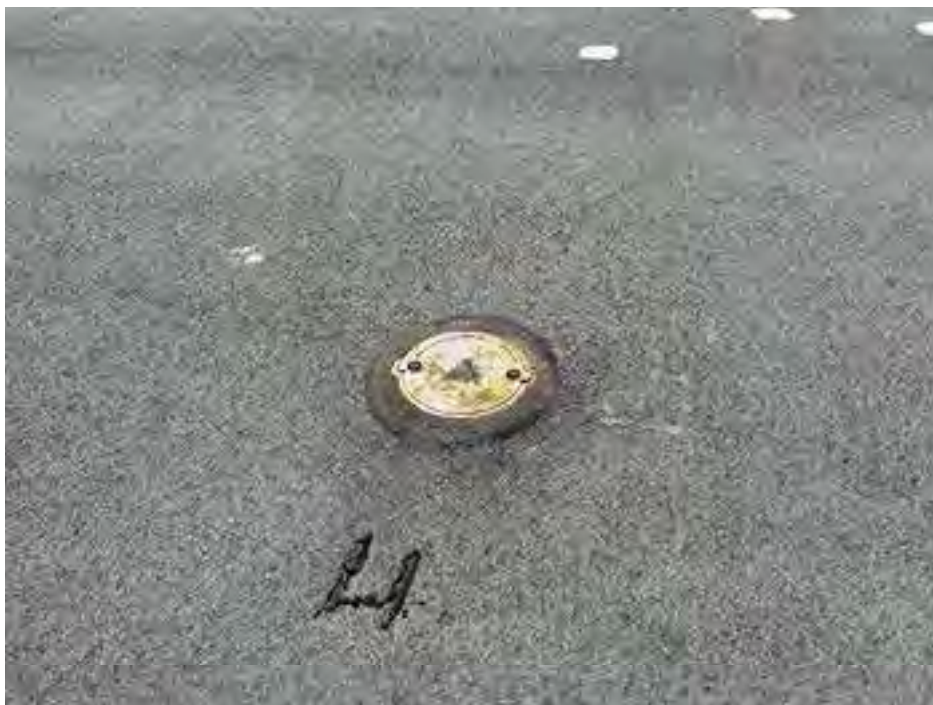
Parcel D-1 Photograph 19: Monitoring well completion and repaired boreholes east of Building 523. Facing southwest.

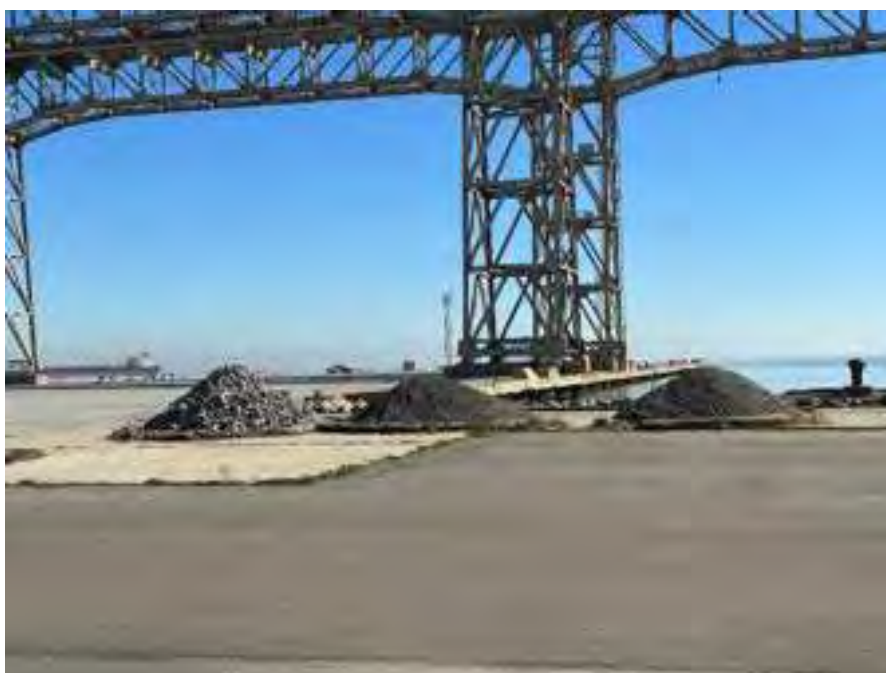
Parcel D-1 Photograph 20: Stockpiles from ongoing work with best management practices surrounding. Facing northeast.

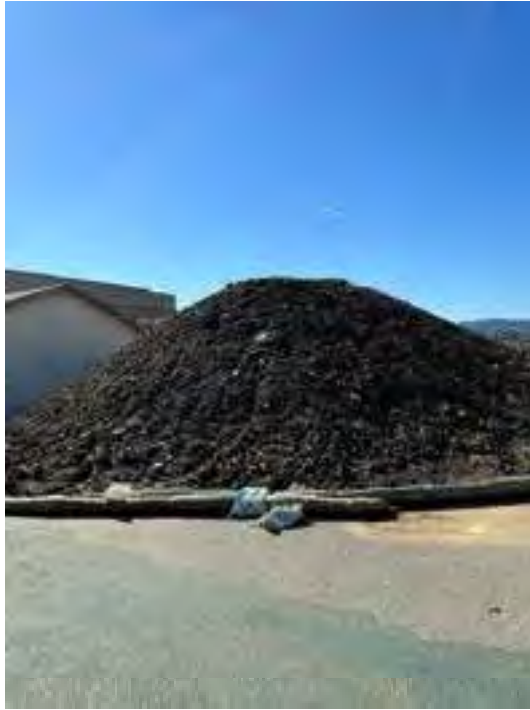
Parcel G Photograph 3: Stockpile with berm surrounding located east of Building 419.
Facing northwest.

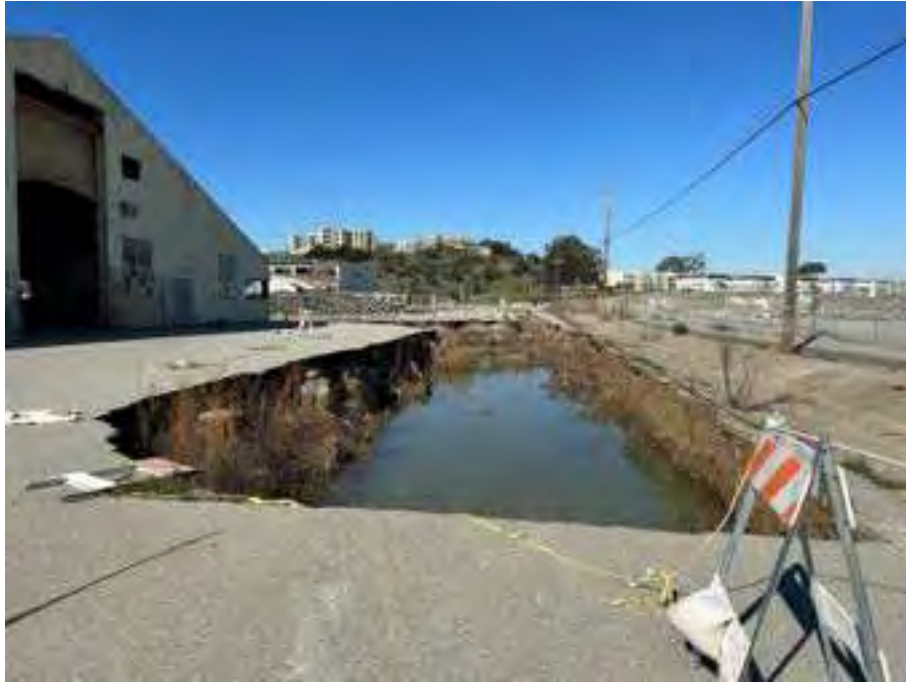
Parcel G Photograph 5: Trenching east of Building 366. Facing northeast.

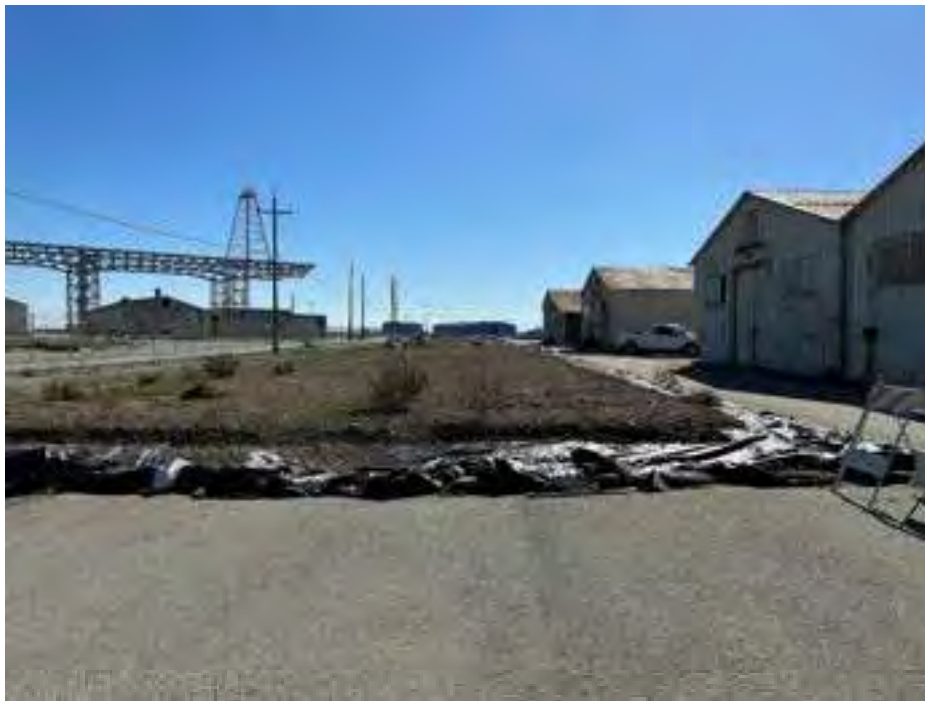
Parcel G Photograph 6: Stormwater best management practice east of Building 415. Facing southeast.

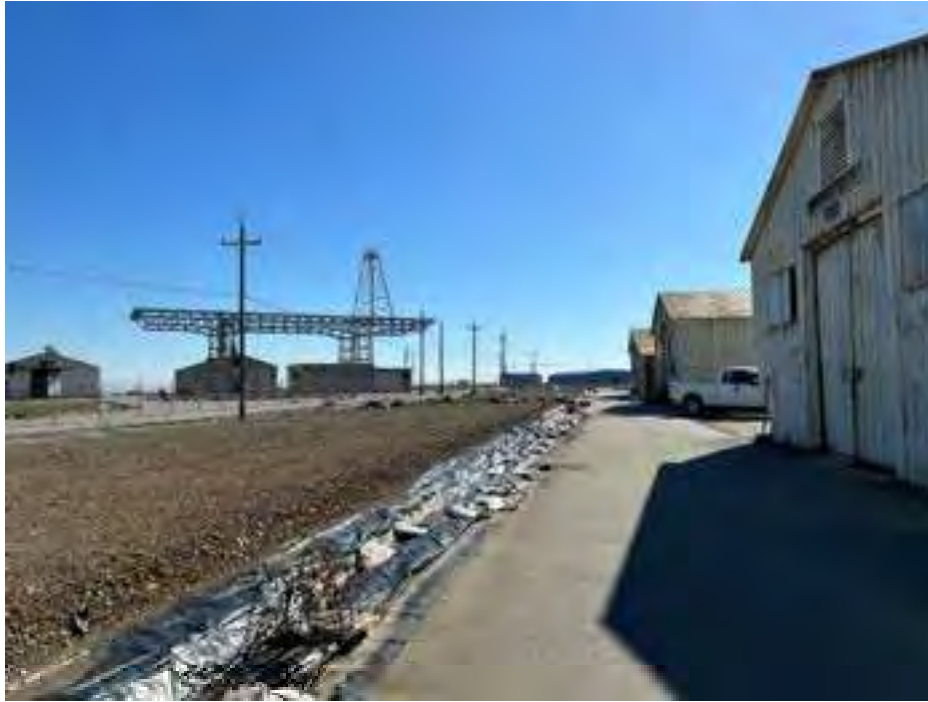
Parcel G Photograph 9: Stormwater best management practice along southeast portion of Parcel G along Buildings 415, 323, and 324. Facing southeast.

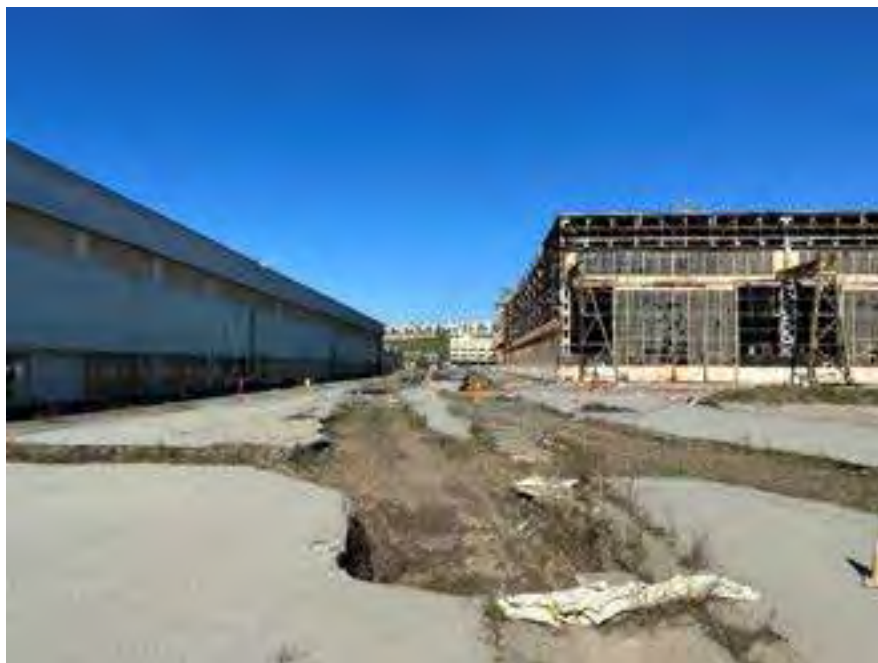
Parcel G Photograph 10: Excavation west of Building 411 and east of Building 439. Facing northwest.

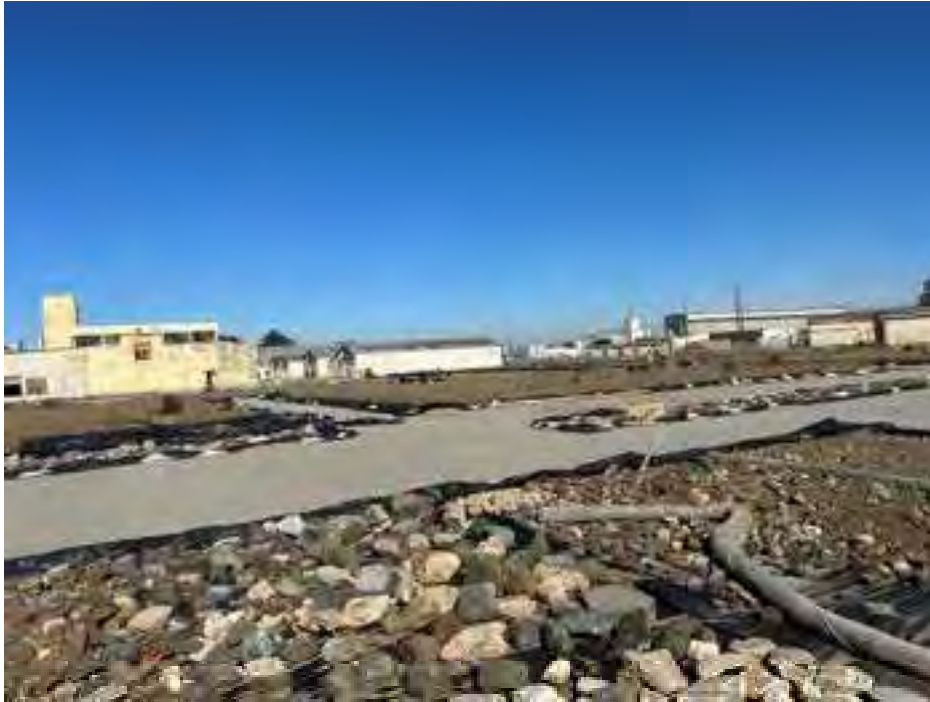
Parcel G Photograph 11: Stormwater best management practice east of Building 409.
Facing northwest.

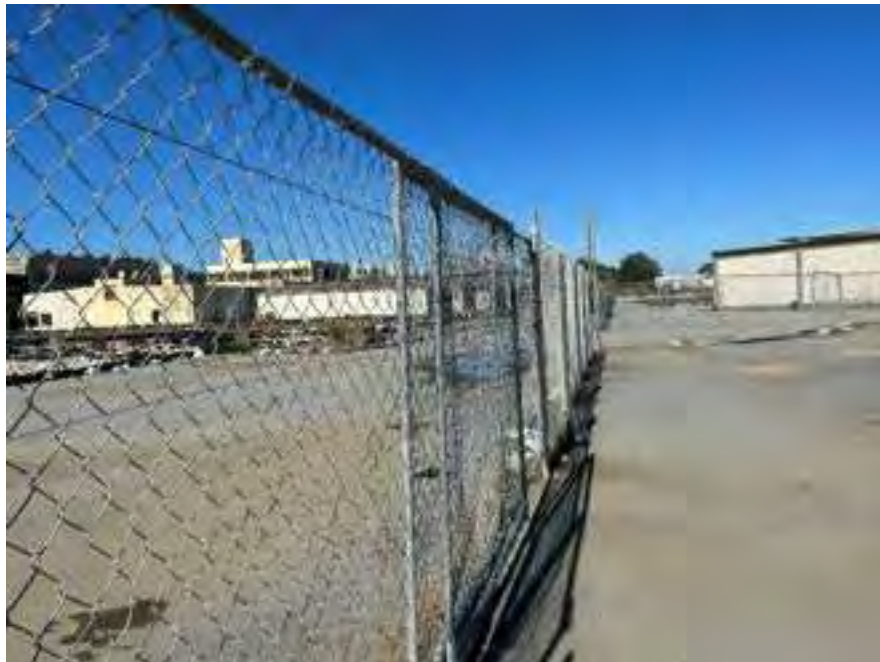
Parcel G Photograph 12: Chain-link fence located east of Parcel G adjacent to Parcel D-1. Facing northwest.
